Conservation and Site Management Plan for Manya Hill, Ghana.

Odarkor Ankrah-Addison

University of Ghana

The aim of this research is to identify the natural and human threats to the dry-stone terraces and building foundations found at Manya Hill and prescribe possible strategies to help reduce and prevent further deterioration.

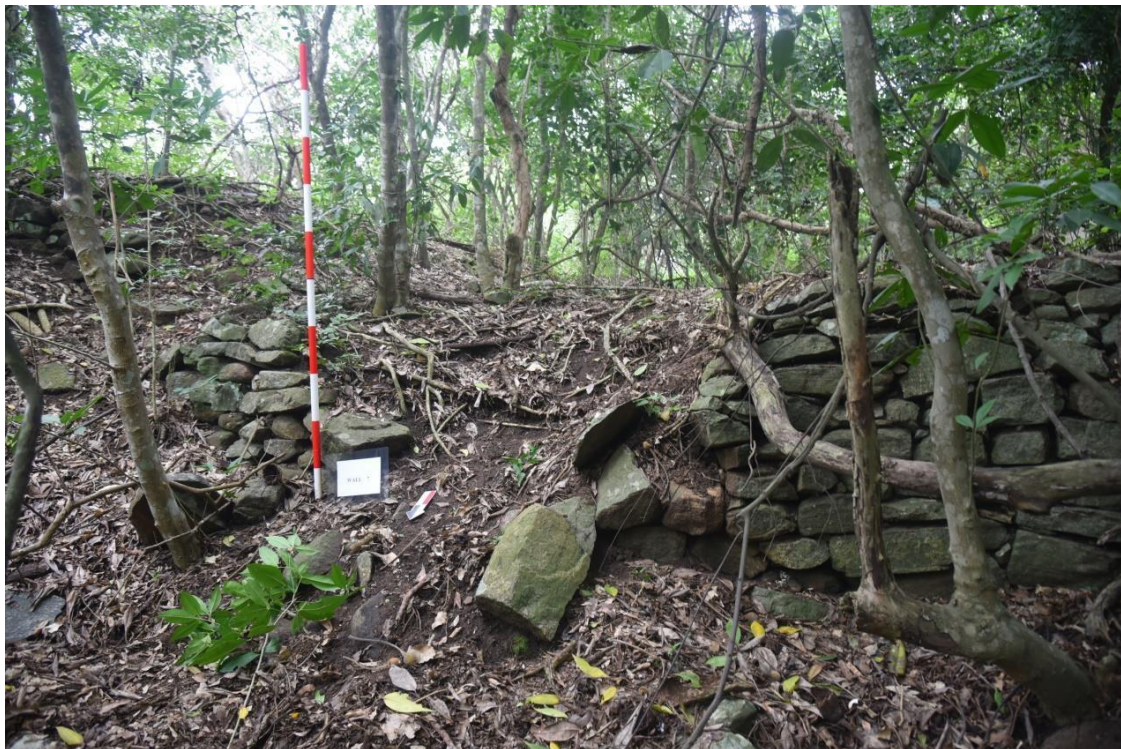
Figure 2: A damaged terrace wall. (Photograph by Miss Odarkor Ankrah-Addison, July, 2020).

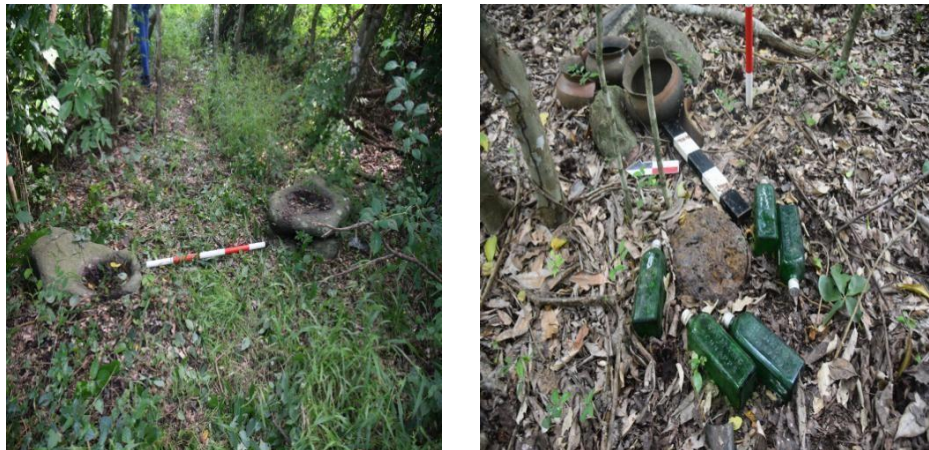
Figure 3: Pictures showing other cultural materials that were captured on the Manya Hill archaeological site. In the first picture are grinding stones and the second picture showing pots and Lateritic stone believed as one of their ancient god (Photographs by Miss Odarkor Ankrah-Addison, July, 2020).

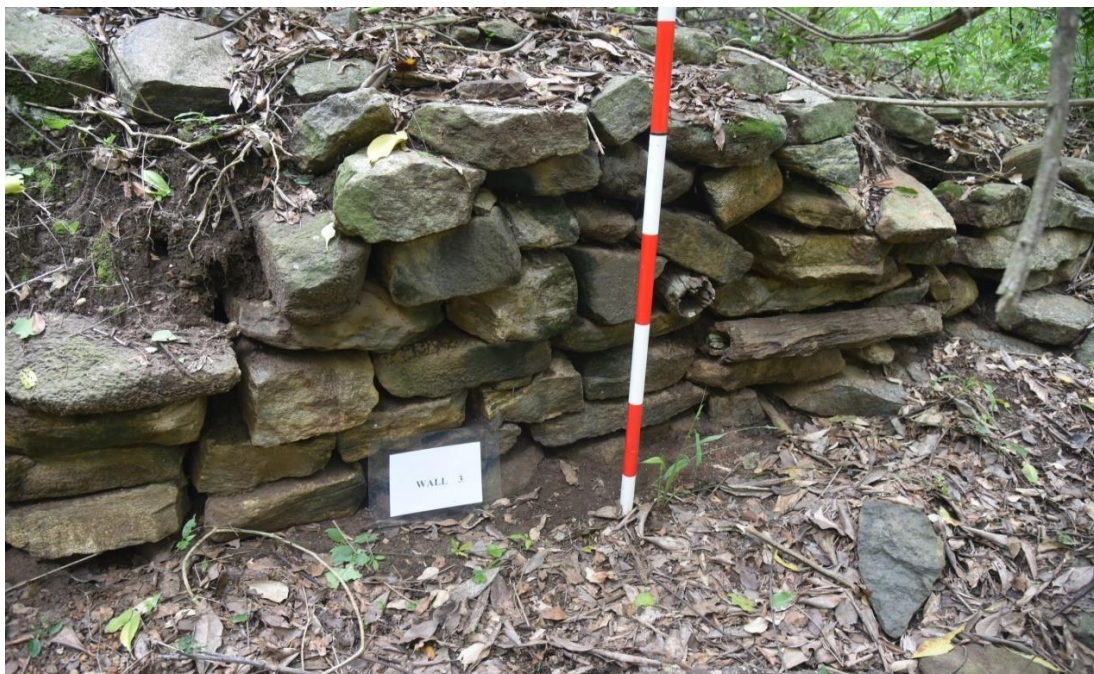
Figure 4: A picture of a terrace wall in the shape of a rectangle with height of 0.9 metres. (Photograph by Miss Odarkor Ankrah-Addison, July, 2020).

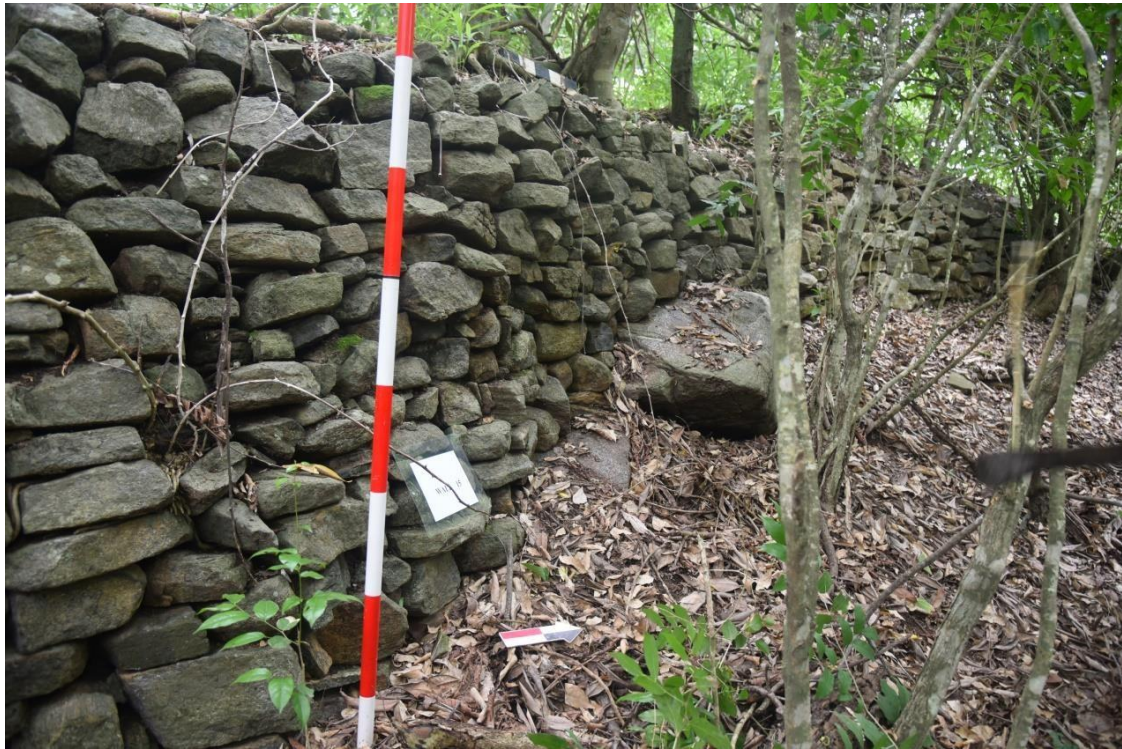
Figure 5: A terrace in a rectangular shape with a height of 1.3metres long (Photograph by Miss Odarkor Ankrah-Addison, July, 2020).

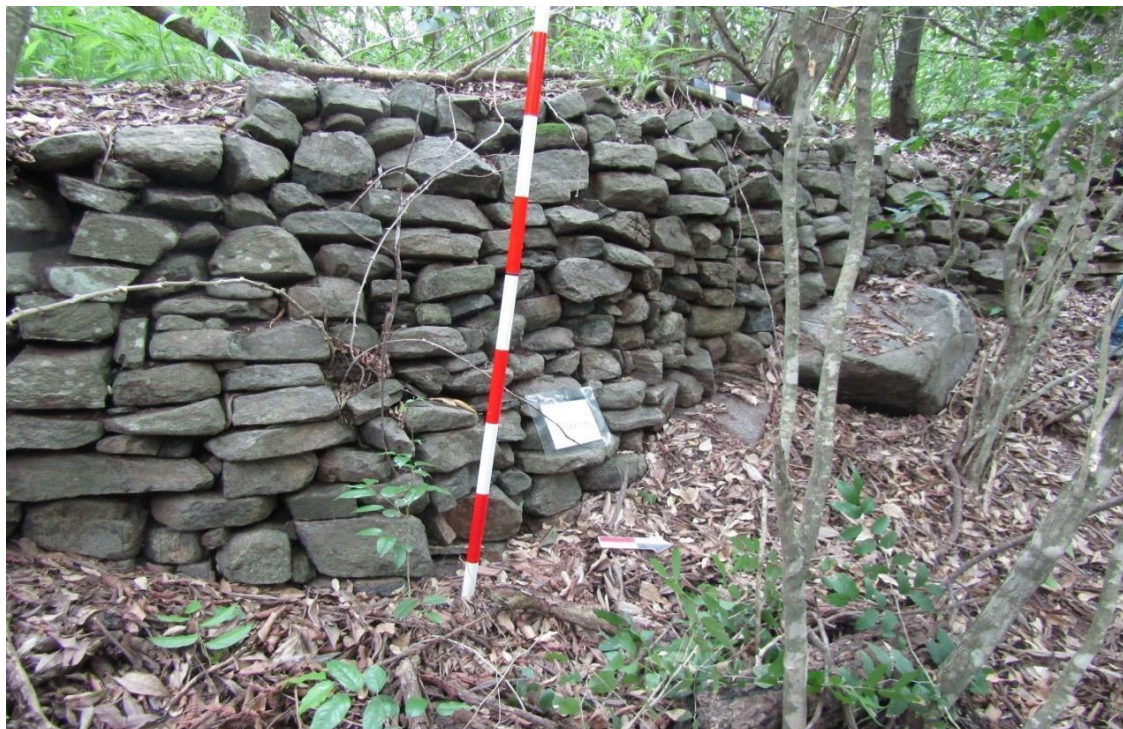
Figure 6: A rectangular shaped terrace wall with height of 1.4metres long (Photograph by Miss Odarkor Ankrah-Addison, July, 2020).

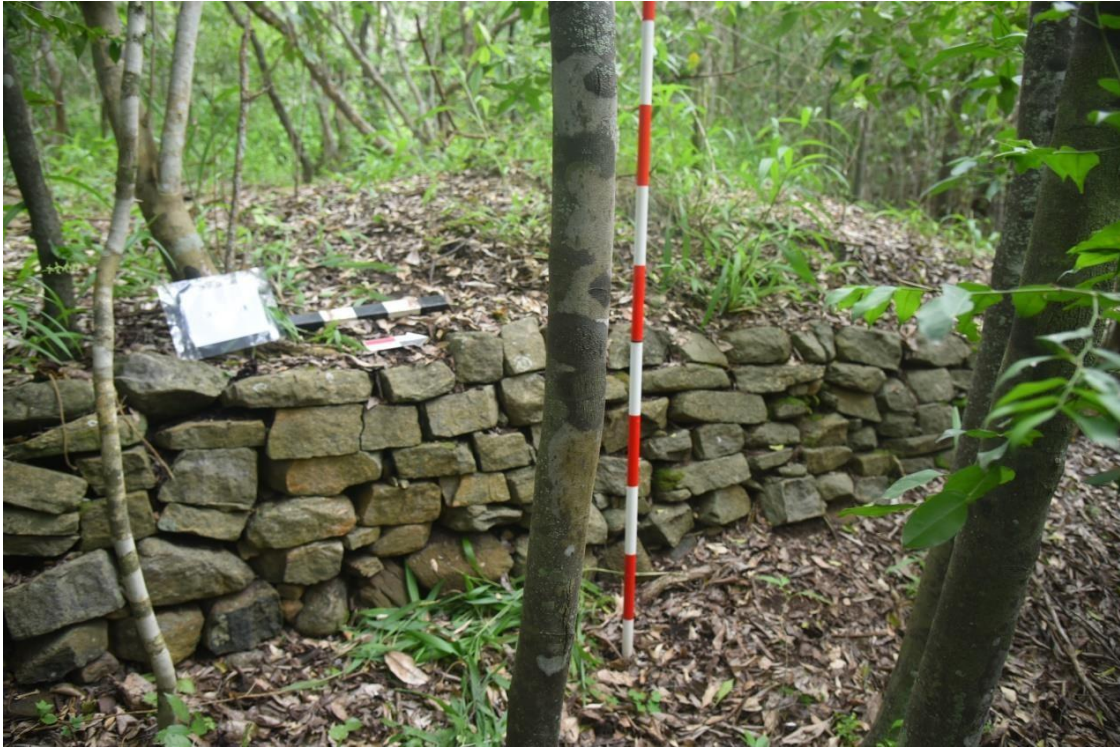
Figure 7: Another picture showing a terrace wall in a rectangular shape layout with height of 0.9metres long (Photograph by Miss Odarkor Ankrah-Addison, July, 2020).

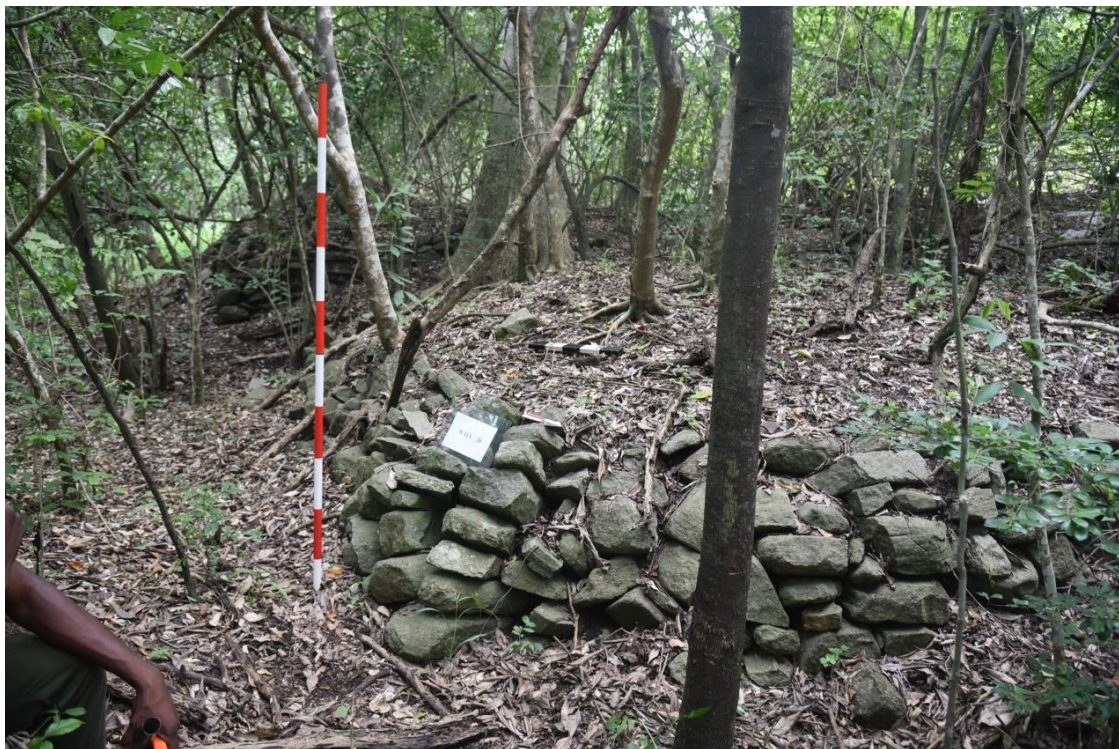
Figure 8: A picture showing a terrace wall that is in the shape of a square with height of 0.63metres long (Photograph by Miss Odarkor Ankrah-Addison, July, 2020).

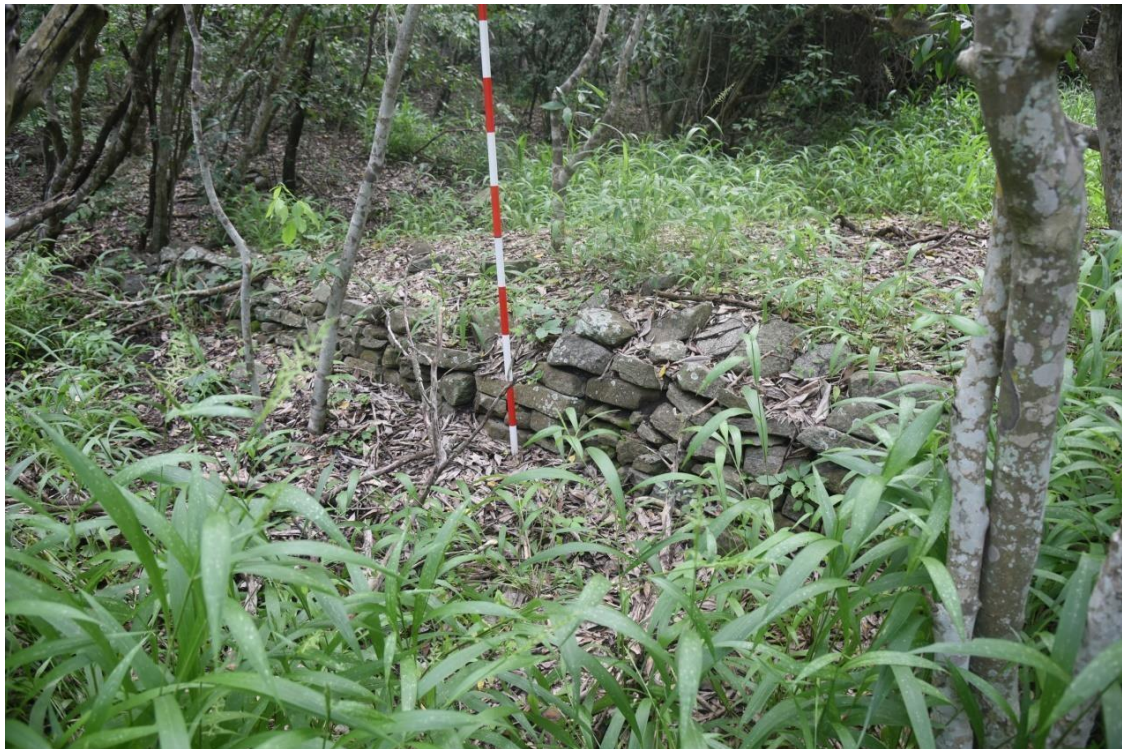
Figure 9: A picture of a square shaped terrace wall with height of 0.67metres long (Photograph by Miss Odarkor Ankrah-Addison, July, 2020).

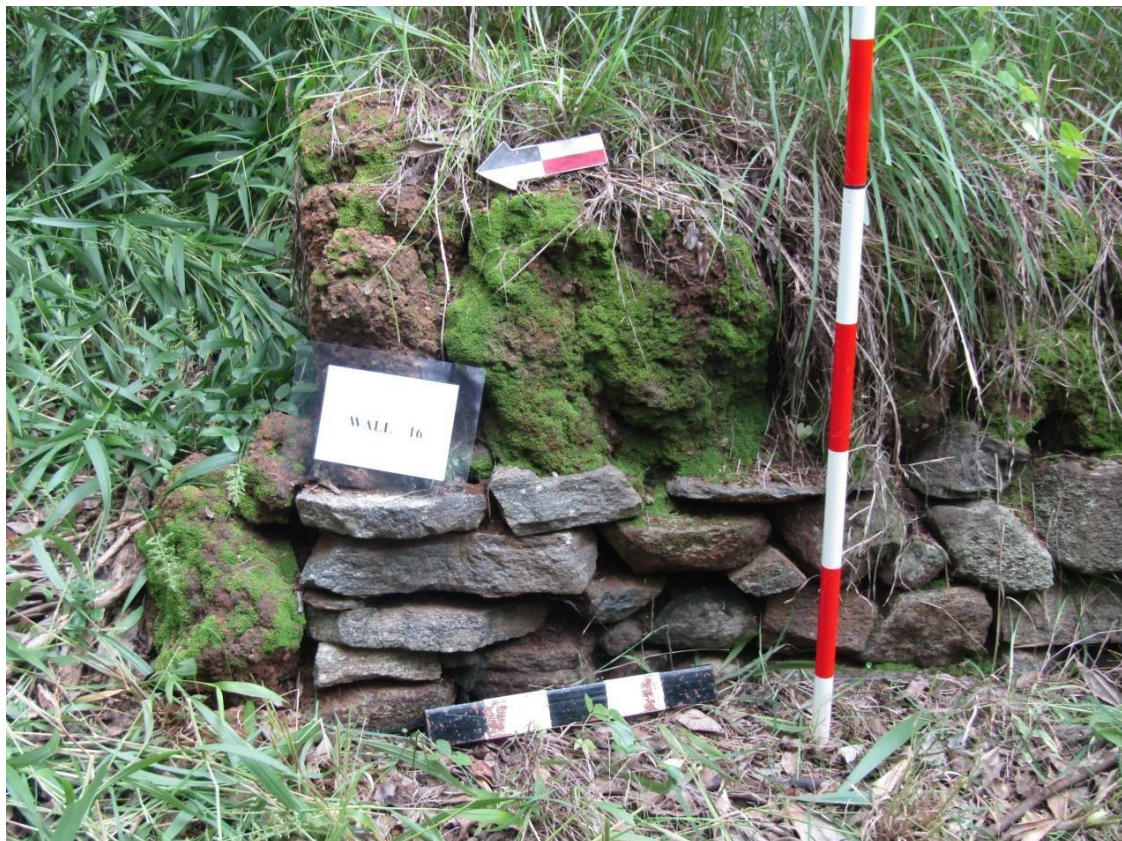
Figure 10: Another picture of a square shaped terrace wall with height of 0.44metres (Photograph by Miss Odarkor Ankrah-Addison, July, 2020).

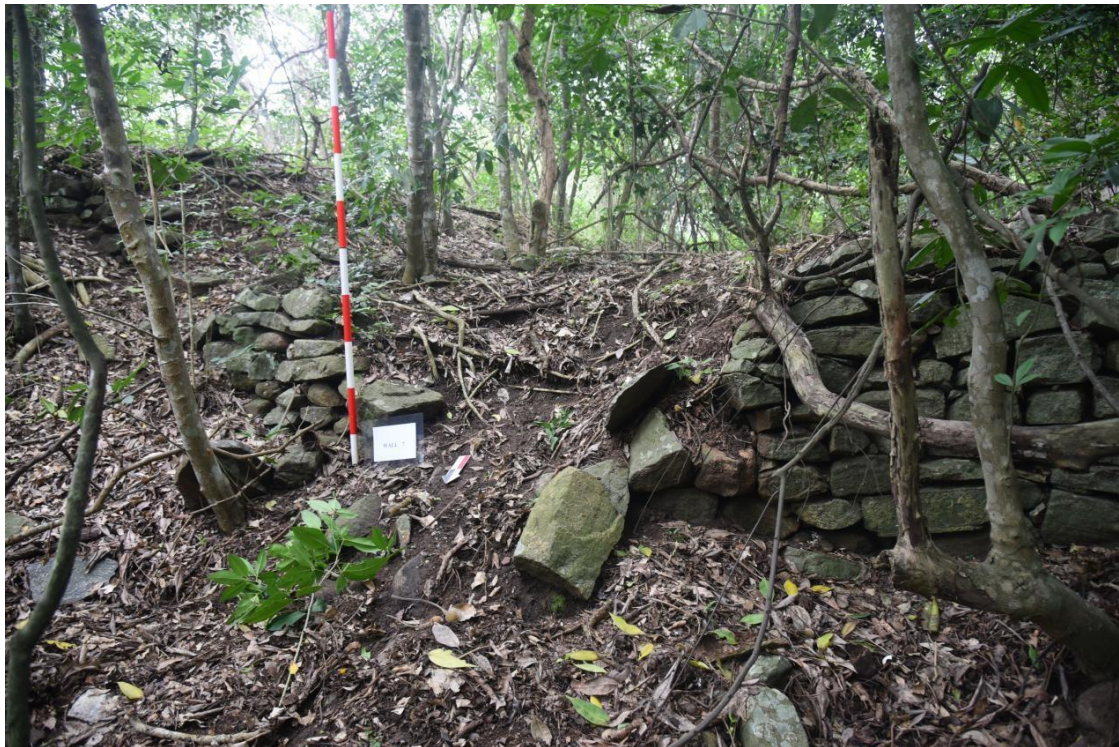
Figure 11: A picture showing how roots and branches of trees pulling and falling stones from their original position to the ground (Photograph by Miss Odarkor Ankrah-Addison, July, 2020).

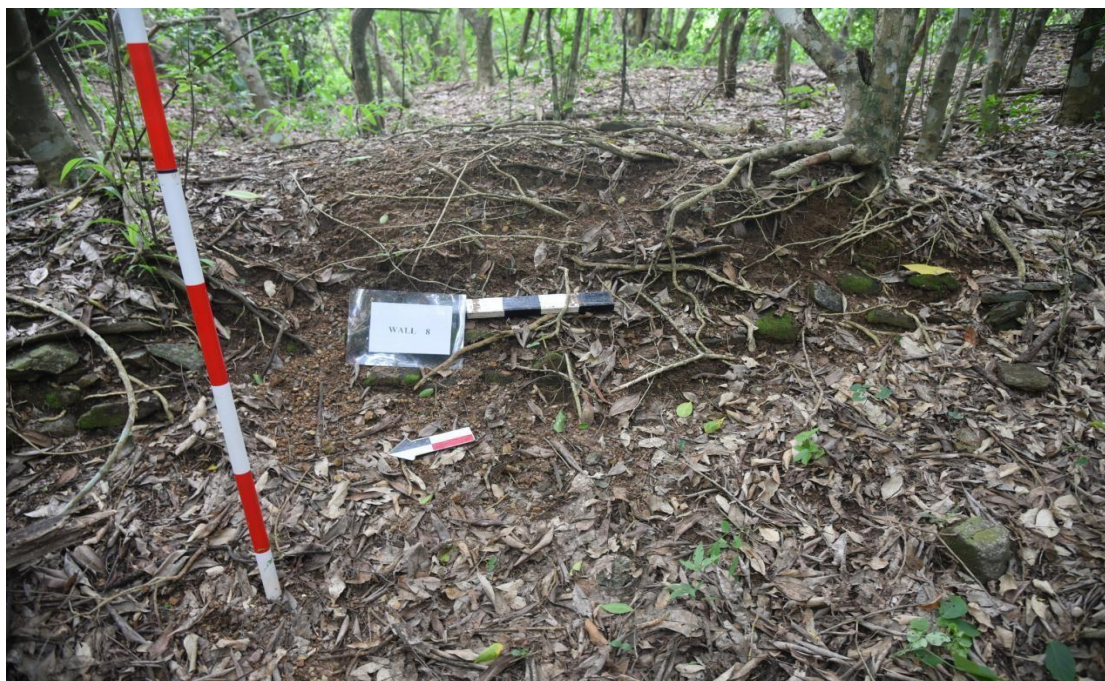
Figure 12: A picture showing how roots of trees have caused the complete removal of all the dry-stones from their original position to the ground (Photograph by Miss Odarkor Ankrah-Addison, July, 2020).

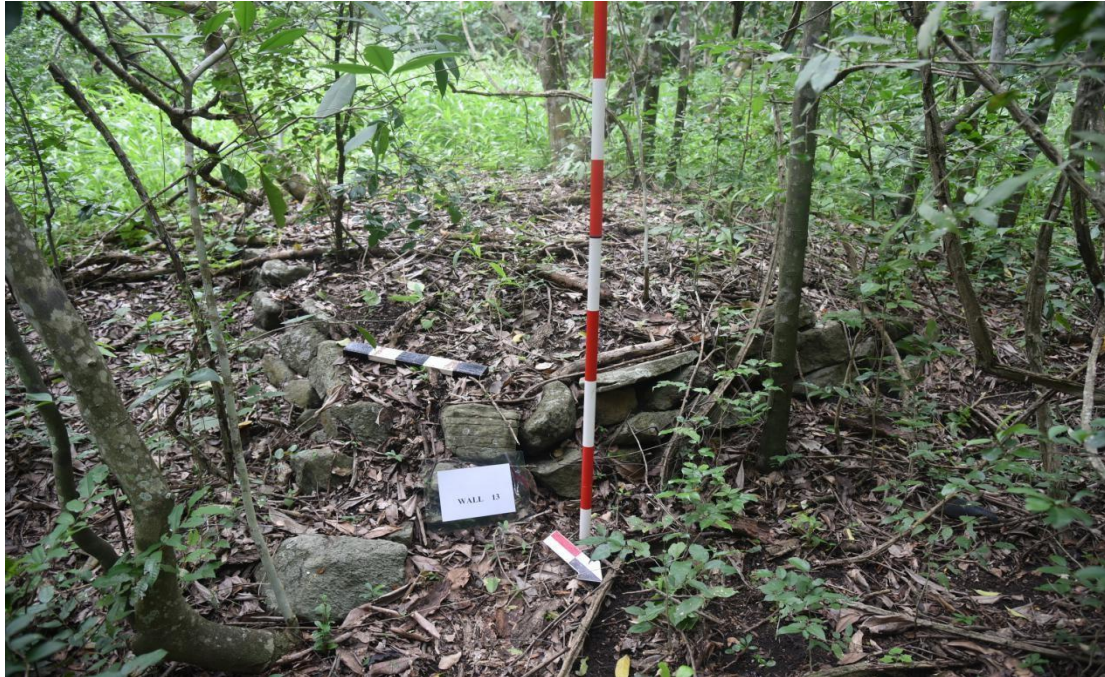
Figure 13: Another picture showing how the roots of trees outside of the terrace pulling down the stones of the terraces (Photograph by Miss Odarkor Ankrah-Addison, July, 2020).

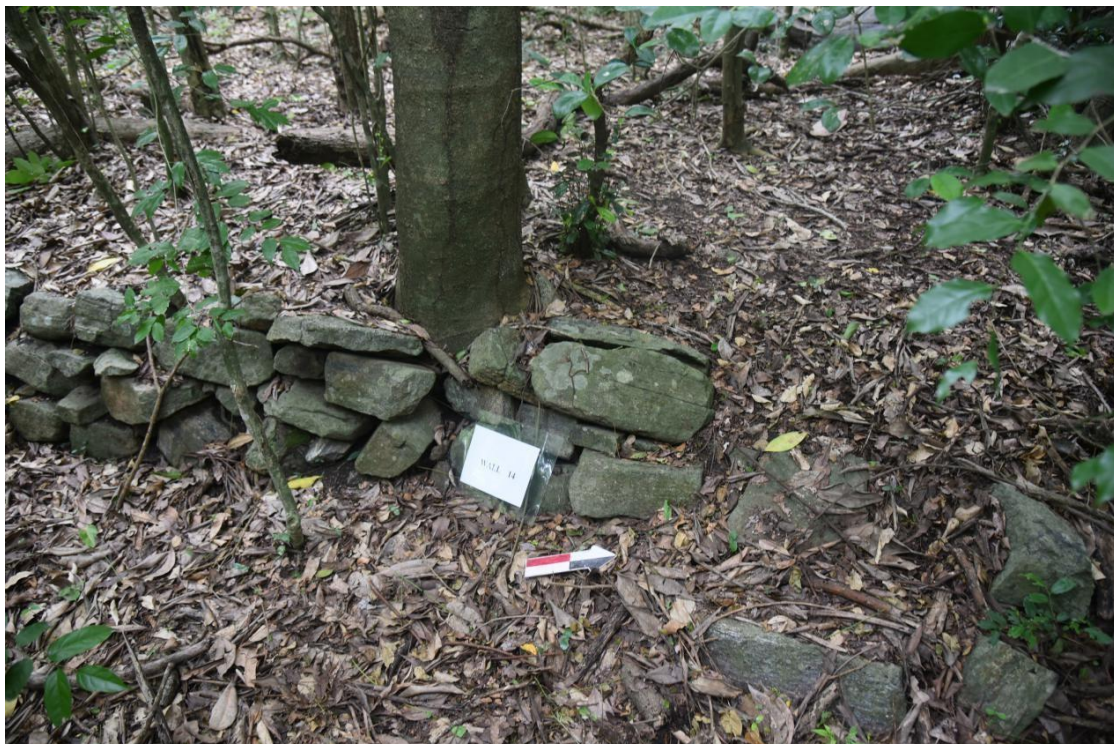
Figure 14: A picture of terraces being brought down by the presence of trees (Photograph by Miss Odarkor Ankrah-Addison, July, 2020).

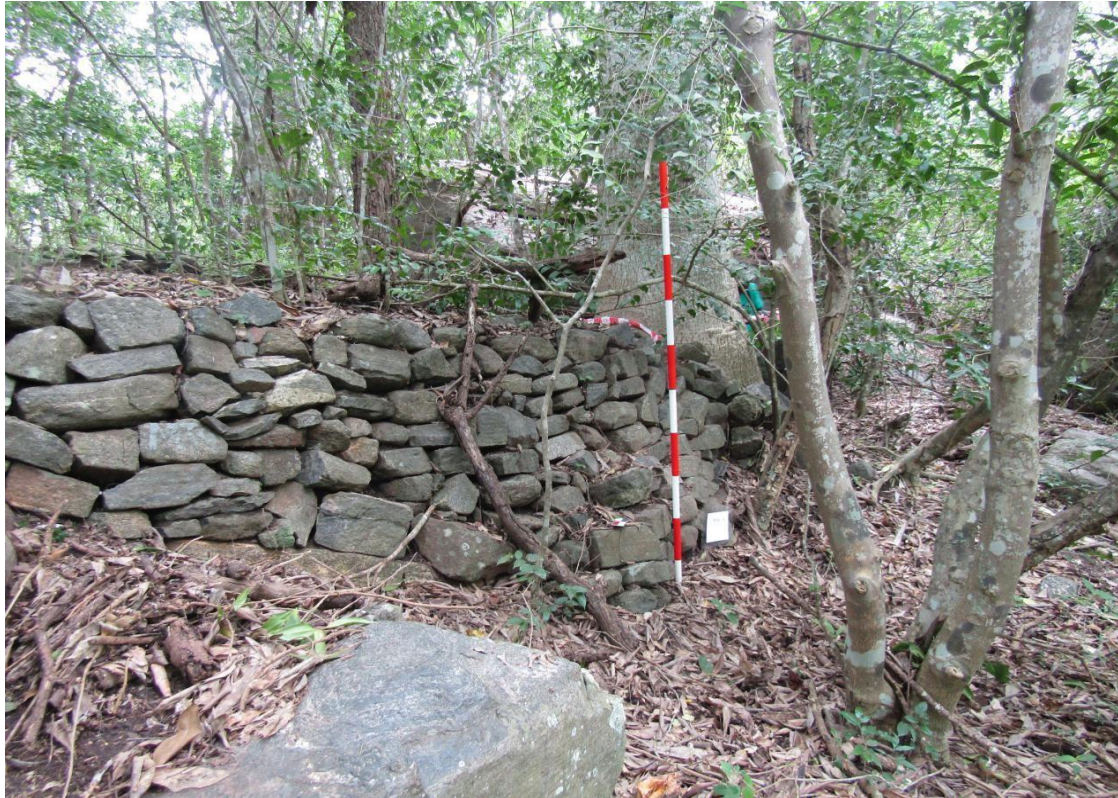
Figure 15: This picture shows the wearing out of the dry-stone terrace walls due to a big tree growing by its side causing the roots to penetrate through the wall (Photograph by Miss Odarkor Ankrh-Addison, July, 2020).

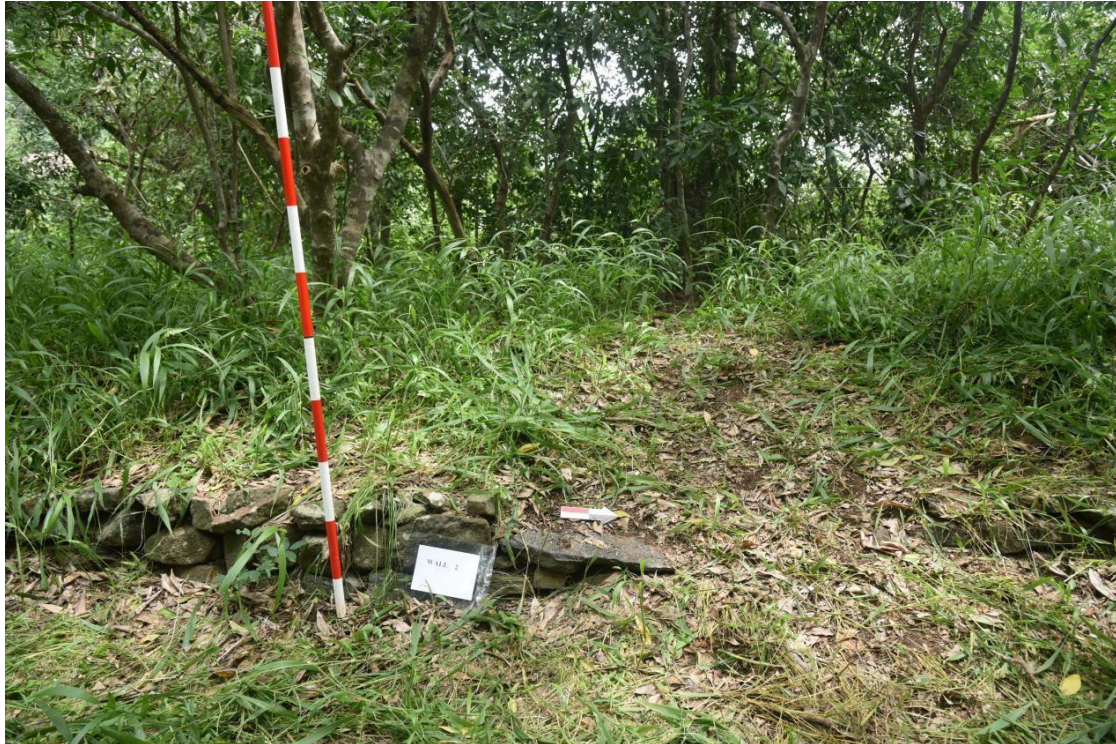
Figure 16: This picture shows how a footpath has been created with the stone terrace (Photograph by Miss Odarkor Ankrah-Addison, July, 2020).

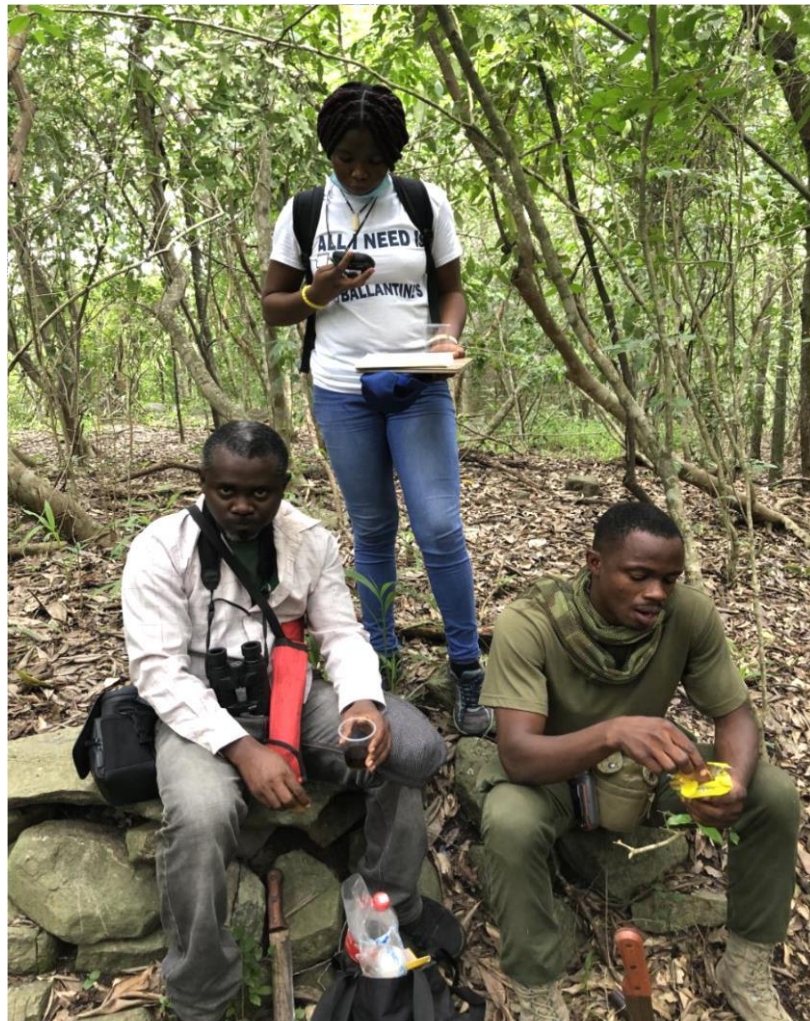
Figure 17: This picture is a demonstration by the tour guide, Mr. Eliezer Ozor and Mr. John Osardu, one of the research assistant showing how tourists sit and relax on some of the dry-stone terrace walls which as a result make them loose their original position and fall of the ground (Photograph by Miss Odarkor Ankrah-Addison, July, 2020).

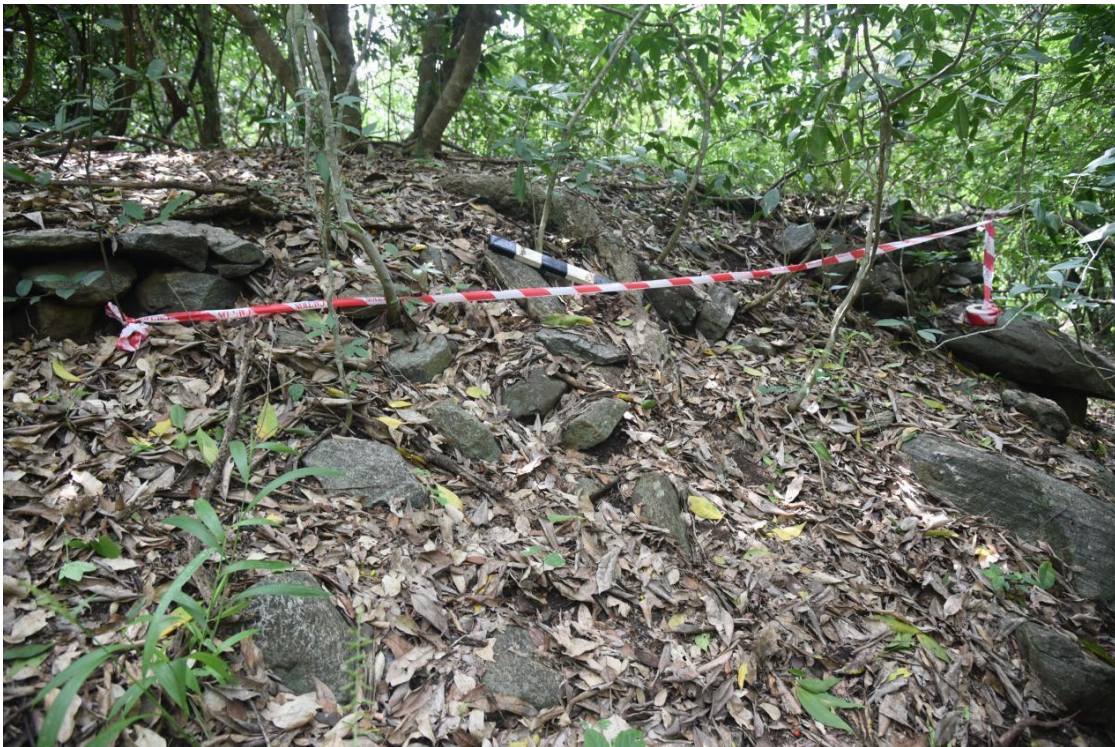
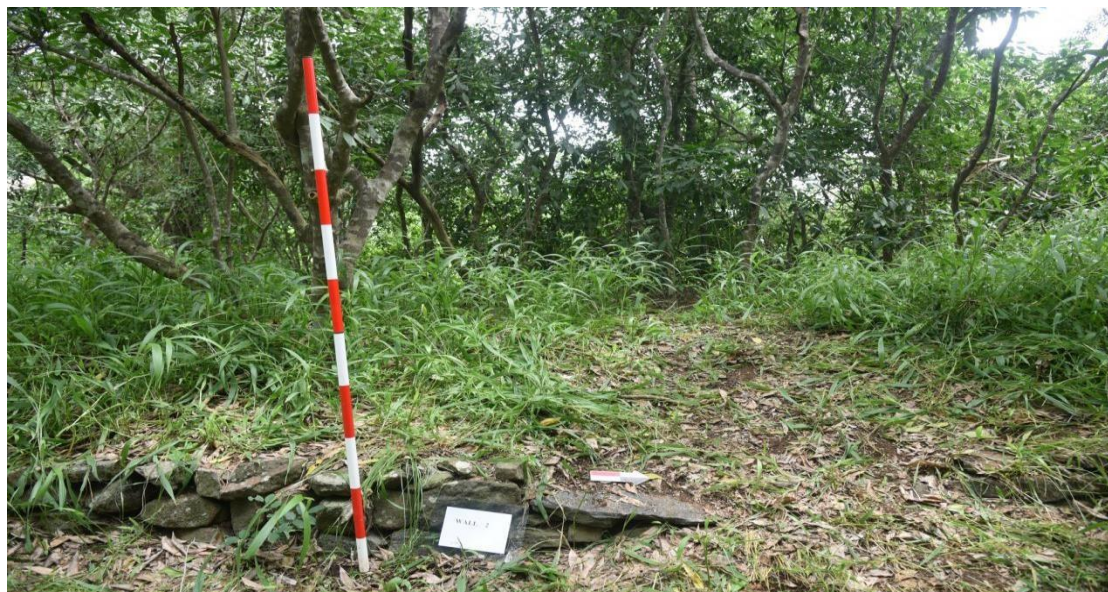
Figure 18: Partly damaged wall (Photograph by Miss Odarkor Ankrah-Addison, July, 2020).

Figure 19: Partly damaged wall.

Figure 18 and Figure 19 above have their severity of the terrace wall to be partly damaged (Photographs by Miss Odarkor Ankrah-Addison, July, 2020).

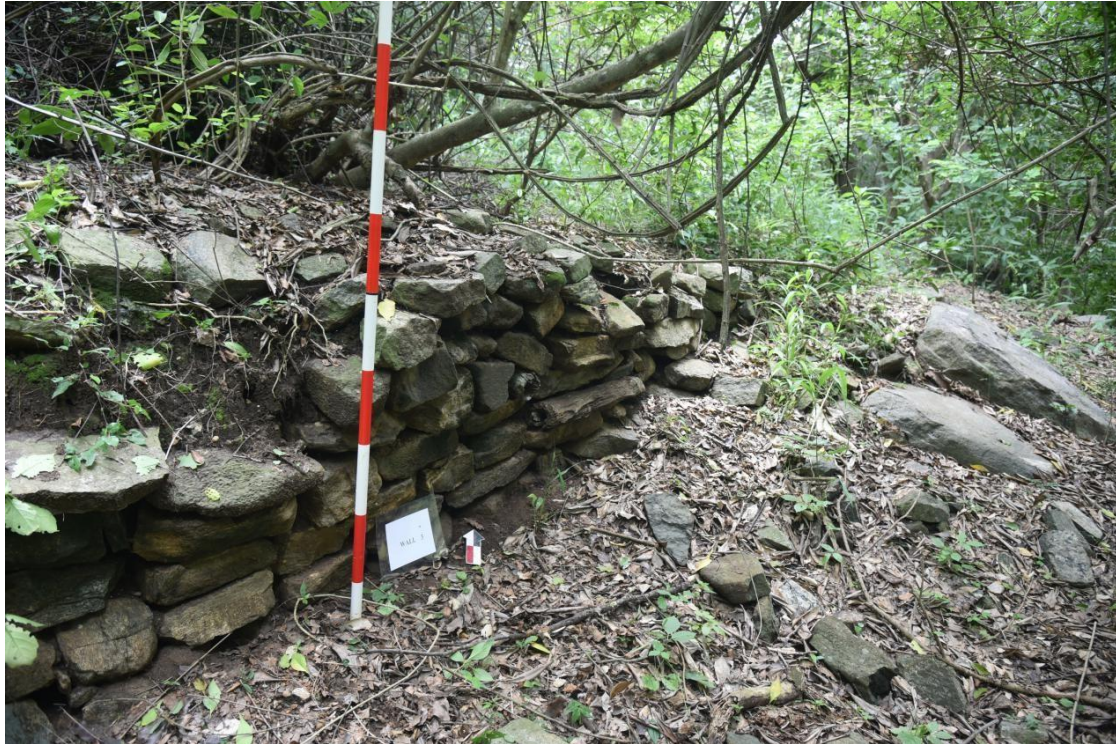
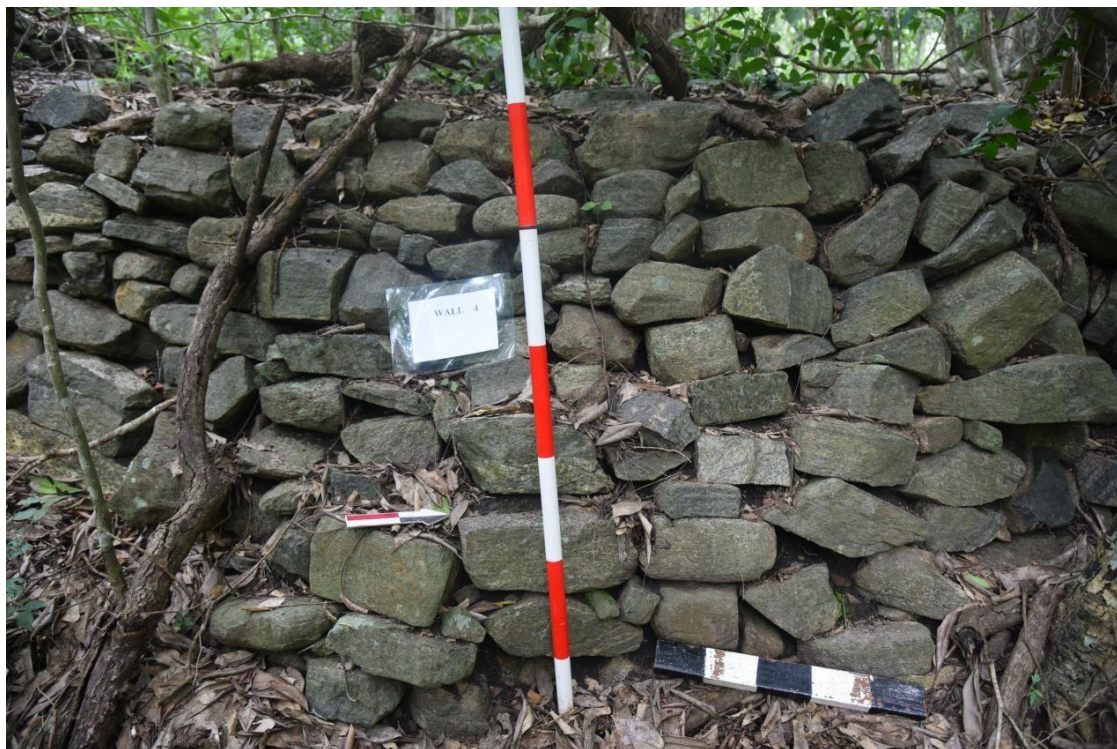
Figure 20: Slightly damaged wall.

Figure 21: Slightly damaged wall.

Figure 20 and figure 21 above also have their severity to be slightly damaged (Photographs by Miss Odarkor Ankrah-Addison, July, 2020).

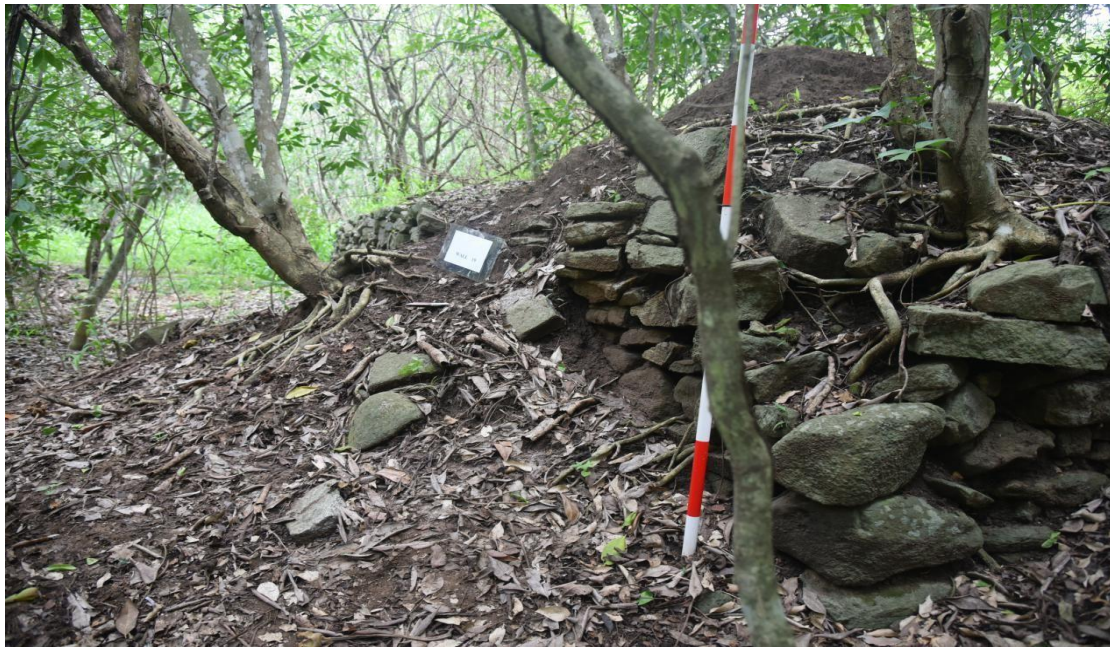
Figure 22: this terrace wall has its severity to be severely damaged (Photograph by Miss Odarkor Ankrah-Addison, July, 2020).

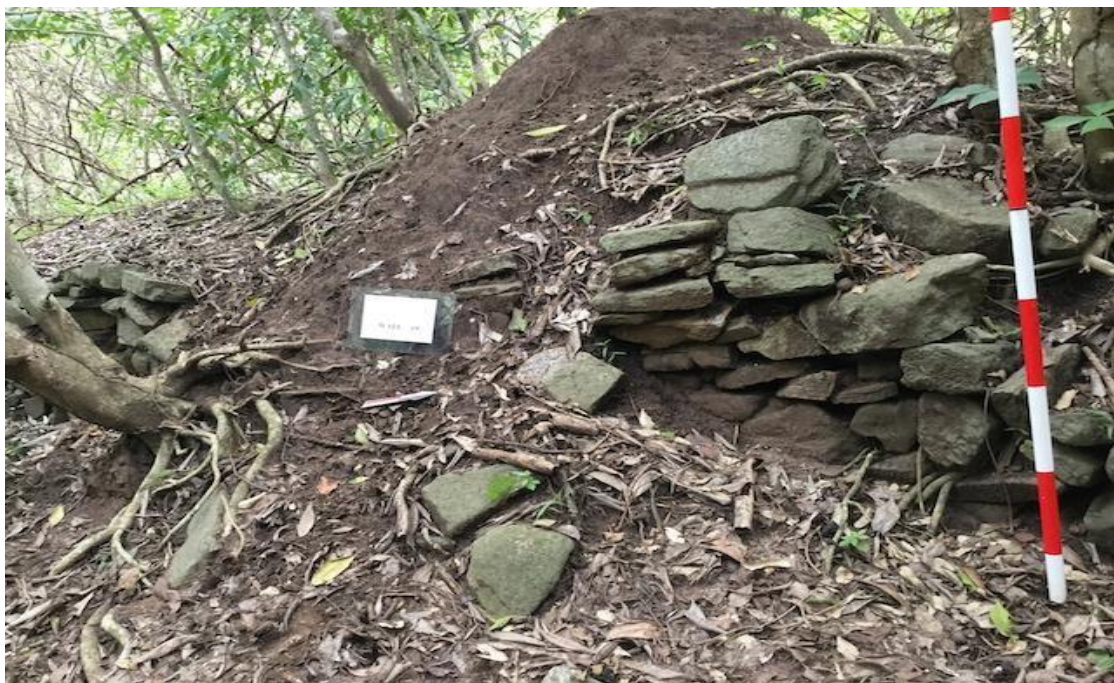
Figure 23: this picture is showing a tree growing in front of a terrace wall and its root causing havoc to the wall. This wall can be saved by felling this tree and removing all of its roots that are penetrating though the walls (Photograph by Miss Odarkor Ankrah-Addison, July, 2020).

4.6.1 Felling of trees; this can be done by removing the trees that are very close to the dry-stone terrace walls and building foundations on the site. The disambiguation of trees can be done by using chainsaw to fell the tree, also after the felling of the tree, all the trees must be bucked and the logs taken away from the site.

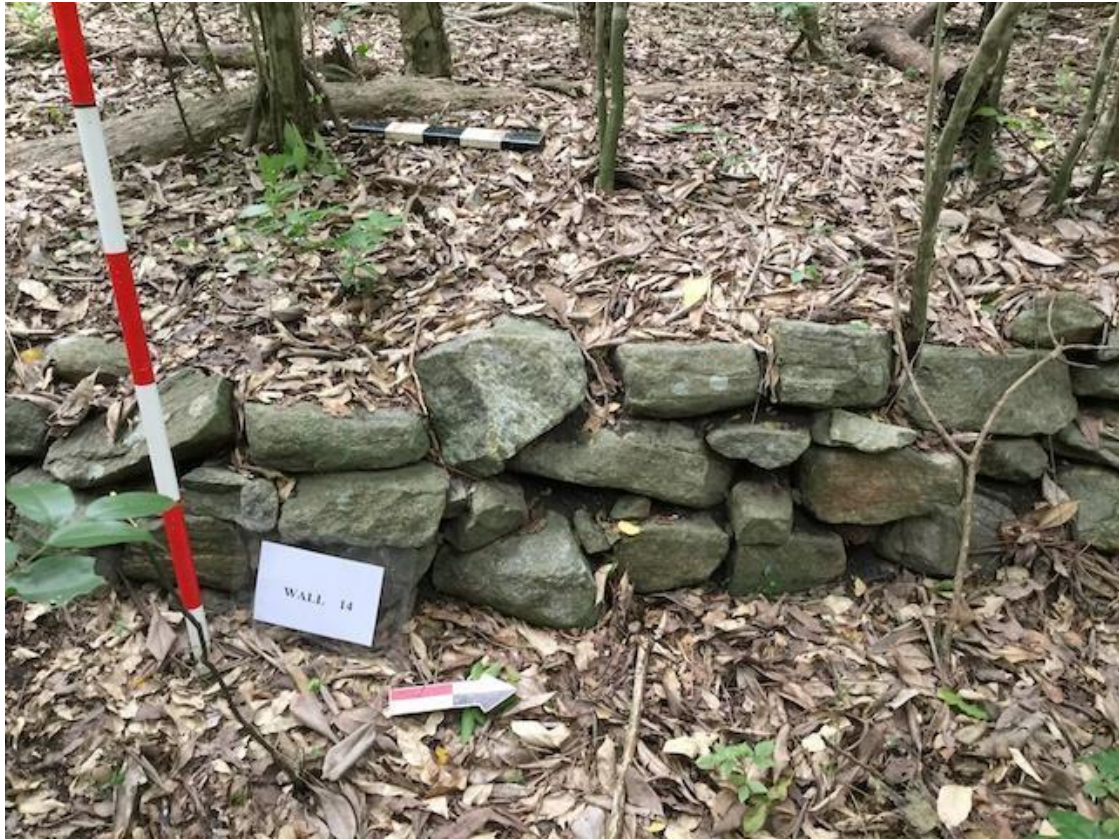
Figure 24: from this picture, it can be seen that the wall is not threatened but trees are growing within and around the terrace wall (Photograph by Miss Odarkor Ankrah-Addison, July, 2020).

This wall can be saved from future threats that may be caused by these trees by removing these smaller trees growing around and within it.

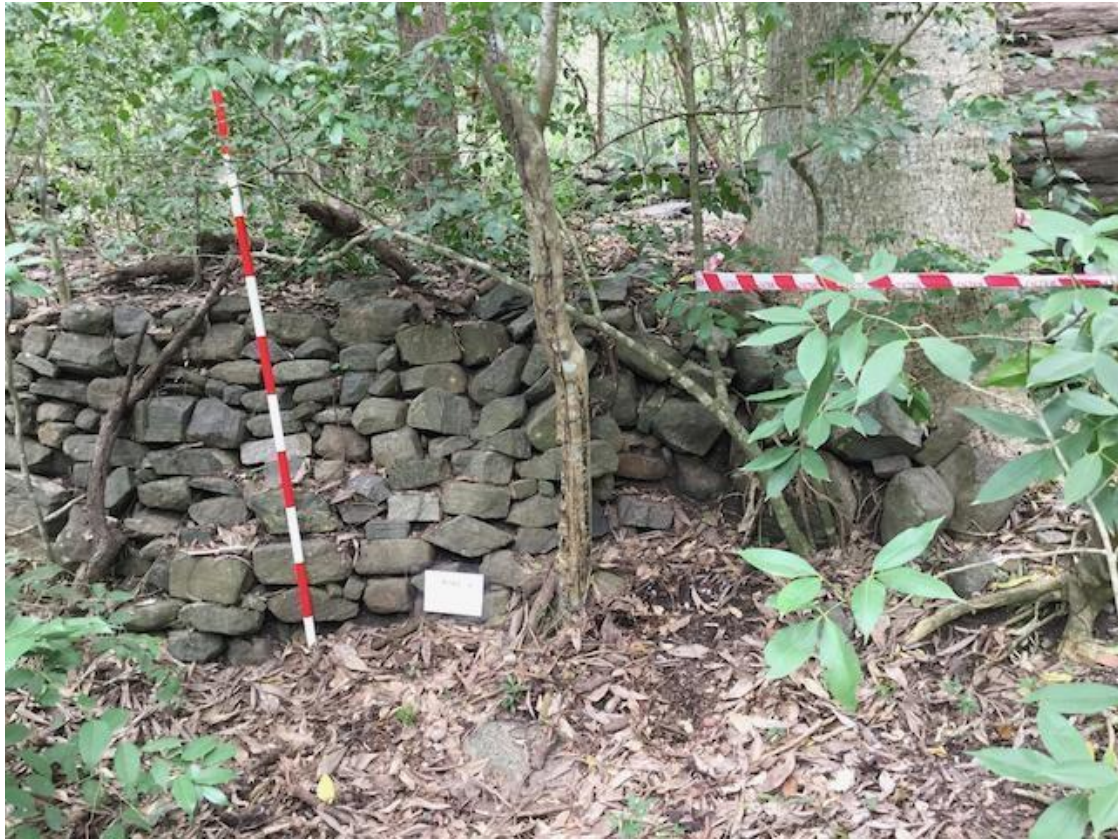
Figure 25: this image is showing a very big tree (Ebony (*diospyros* sp)) and smaller ones growing around. This particular dry-stone terrace wall cannot be saved but be left to its fate since the big tree cannot be fell.

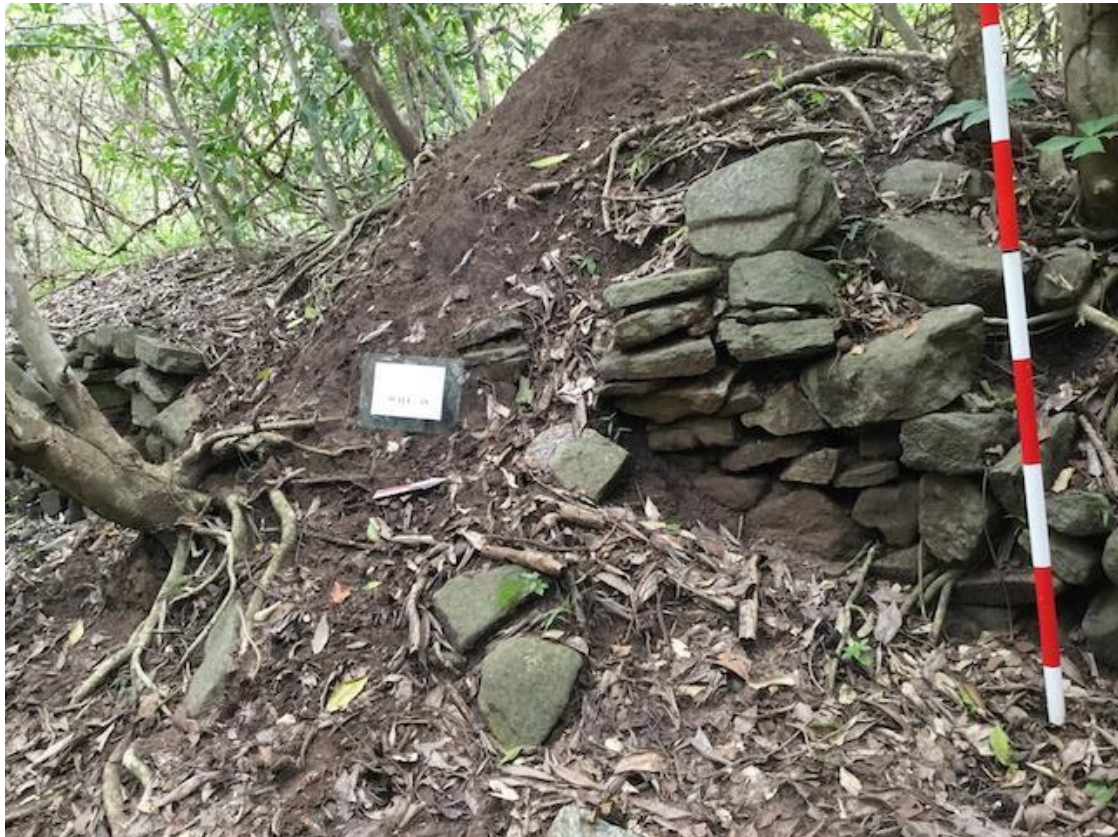
Figure 26: even though in this picture there is a presence of a tree, the ant hill built on top of the terrace wall is also adding up to the destruction of the wall.

To help prevent further and future deterioration, it is best to remove or destroy all ant hills or mounds that are built by the animals on top of the walls and are causing shifts and destruction of dry-stone terrace wall on the Manya Hill site. The picture below shows an ant hill on a terrace wall that was recorded on the site.
