# Comparative Structural Audit of Low-Rise and Mid-Rise RCC Buildings Using Non-Destructive Testing Techniques

## Abstract

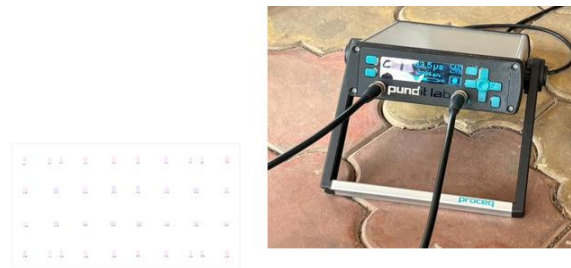
Columns and beams were selected as the primary structural members for testing. Test points were located at the mid-height of columns and the soffit of beams, at positions that were structurally representative and physically accessible on every floor of each building. Test-point layouts for both buildings are shown in Fig. 1.

**Fig. 1. Structural test-point layout: (a) Mid-rise building (G+4) column grid; (b) Low-rise building (G+1) column grid**

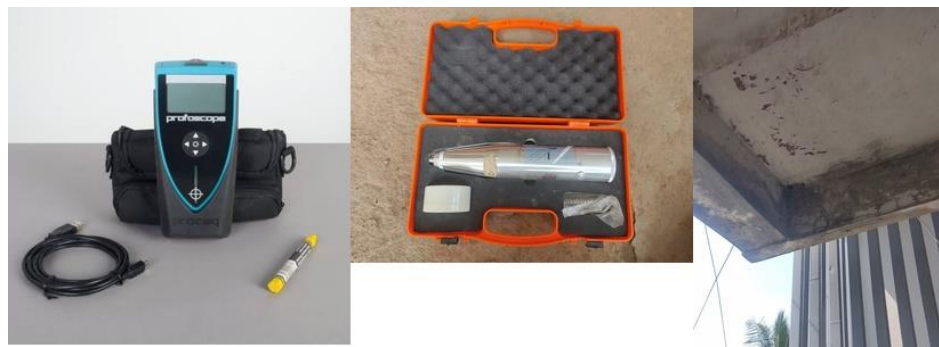
**Fig. 2. Field instruments used: (a) Rebound Hammer; (b) Ultrasonic Pulse Velocity (UPV) tester; (c) Rebar Locator (cover meter)**

A spring-controlled mass is impacted against the concrete surface through a plunger; the rebound distance, expressed as the Rebound Number, is correlated with surface hardness and hence approximate compressive strength. Higher rebound numbers indicate denser, stronger concrete. Surfaces were cleaned and smoothened prior to testing, the hammer was held perpendicular to the surface, and multiple readings were taken and averaged at each location per manufacturer and code guidance.

An ultrasonic pulse is transmitted through the concrete member between a transmitting and a receiving transducer coupled to the surface with gel; the transit time is used to compute pulse velocity, which depends on the density, elastic properties and internal homogeneity of the concrete. Higher velocities indicate dense, well-compacted concrete free of significant voids, while lower velocities suggest cracking, honeycombing or deterioration.

An electromagnetic cover-meter was used to verify the position, spacing, approximate diameter and concrete cover of embedded reinforcement at the tested locations, ensuring that Rebound Hammer and

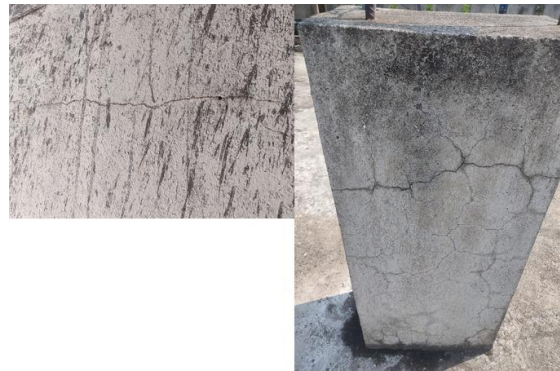
Visual inspection revealed hairline shrinkage/thermal cracks on beam surfaces and wall-plaster junctions, dampness and moisture patches near beam-column junctions and terrace slabs (attributable to inadequate drainage and rainwater exposure), minor surface weathering/discolouration, and localised honeycombing at beam corners consistent with minor compaction deficiencies during casting. No major structural cracking, excessive deflection or distress was observed in primary members (columns and beams) in either building; defects were predominantly serviceability-related rather than indicative of structural distress. Representative site conditions are shown in Fig. 3.

**Fig. 3. Representative visual defects observed during inspection: (a) dampness/staining at a beam soffit; (b) hairline surface crack on a column face**

- Cracked and damp-affected portions identified during visual inspection should be monitored periodically and repaired using appropriate crack-injection or patch-repair techniques.

- Waterproofing treatment should be provided at terrace and roof slab locations to prevent continued moisture penetration, particularly where water stagnation was observed near overhead tanks.

- Proper roof/terrace drainage slope and outlets should be maintained to avoid water stagnation, which was identified as a contributing factor to dampness and long-term durability reduction.

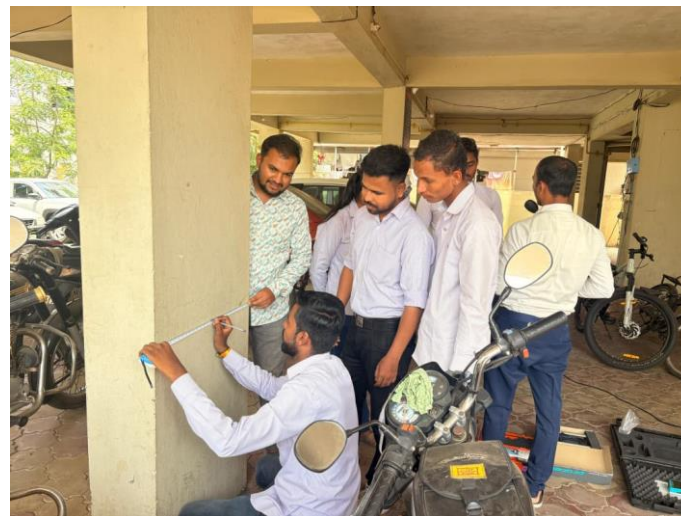
**Fig. 4. Field investigation in progress — Rebound Hammer and Rebar Locator testing on a column**
